# Youth Conservation Corps

## Final Report 2014

Thompson Lake Environmental Association

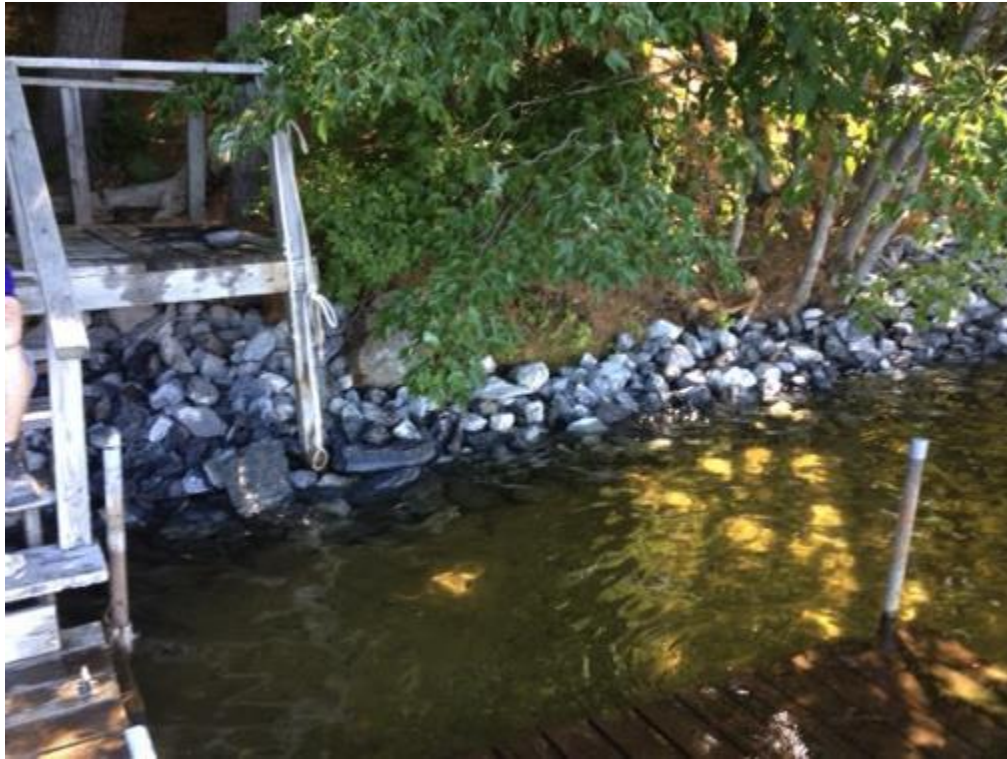
Oxford

Problem: This shoreline was eroding due to its steep slope and exposure to waves and ice.

Solution: The YCC hand-placed rip-rap to prevent further erosion and undercutting.

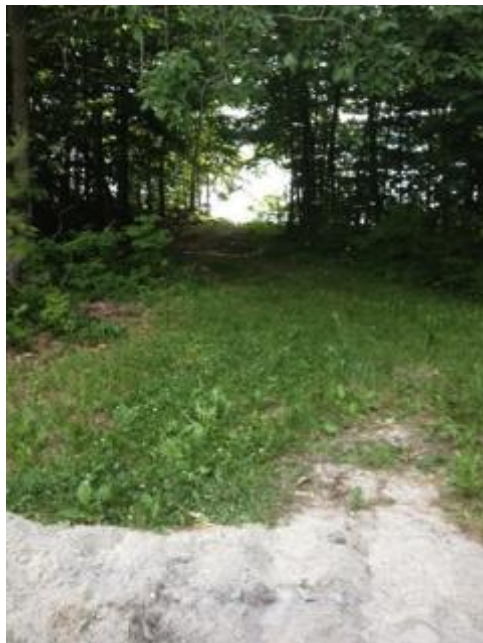
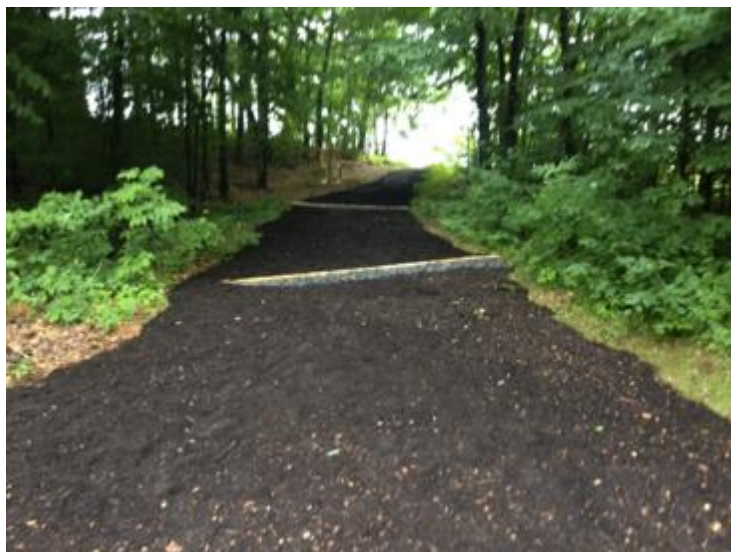
**Thompson Lake Shores Association  
Right-of-Way  
Thompson Lake Shores Rd.  
Casco (319)**

**Problem:** The right of way for Thompson Lake Shores Association was losing coverage from foot traffic and starting to erode.

**Solution:** The YCC installed two water-bars and mulched the entire right of way with Erosion control mix. This should divert water off from the pathway and reduce the impact of foot traffic.

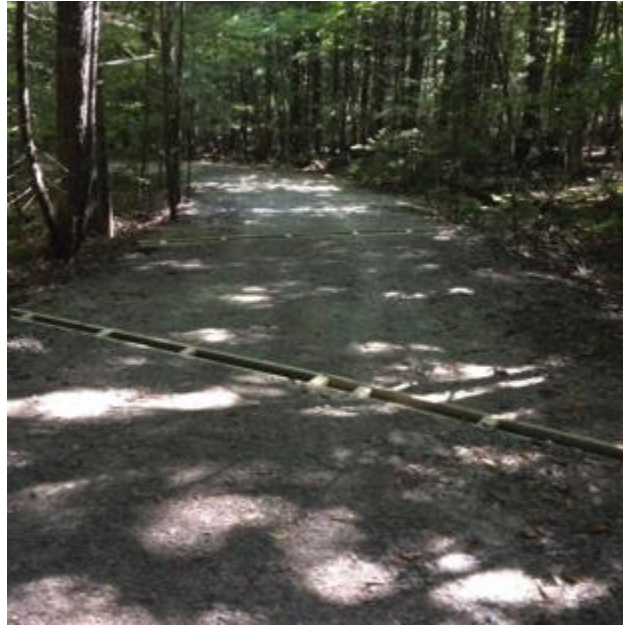
**Poland (319)**

Problem: This driveway was scouring, creating concentrated channels for water run-off.

Solution: The YCC installed four box-culverts to divert water from the driveway.

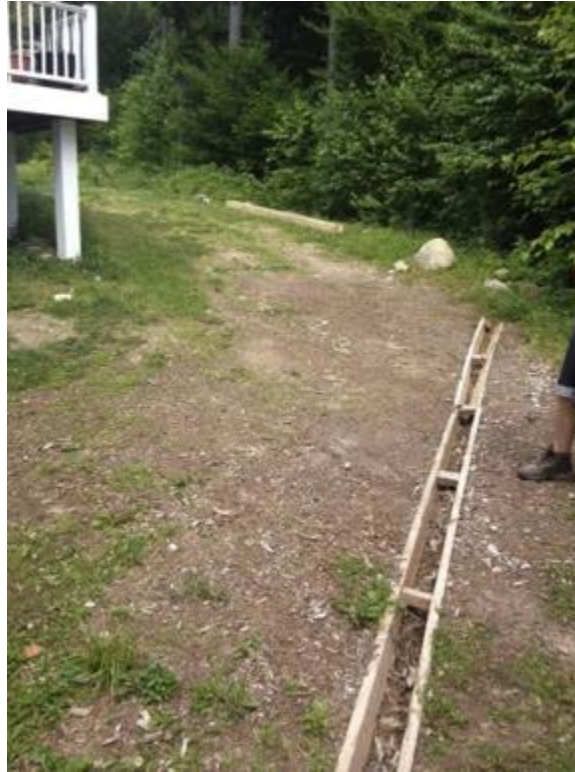
Poland (319)

Problem: This pathway was eroding from frequent foot traffic and seasonal run-off. He had box culverts installed, however they were built incorrectly.

Solution: The YCC replaced existing box culverts with a more stable box.

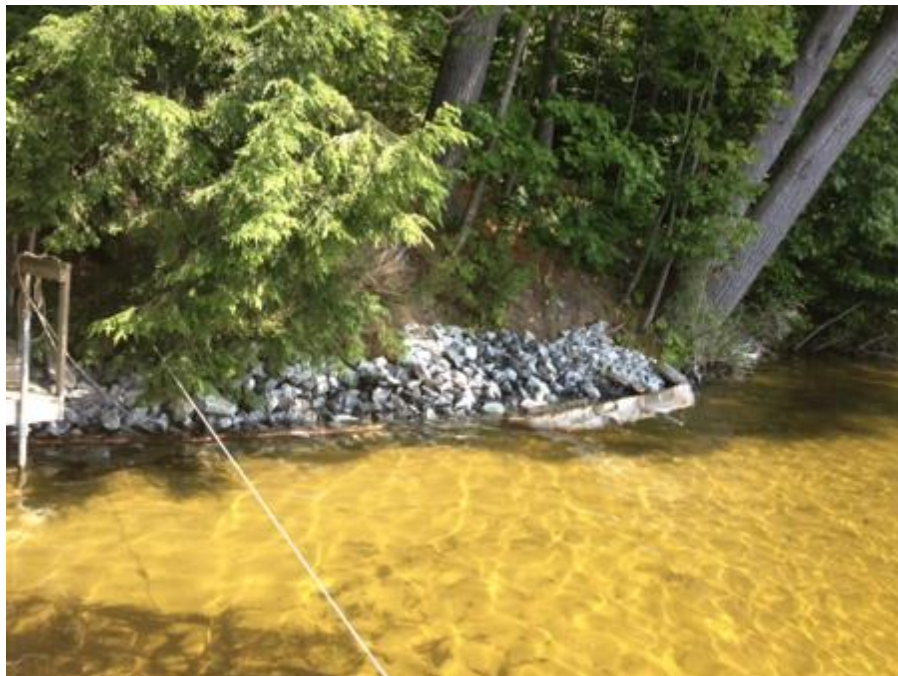
**Oxford**

Problem: This shoreline was eroding due to its steep-slope and prolonged exposure to waves and ice.

Solution: The YCC hand-placed rip-rap to protect against further erosion.

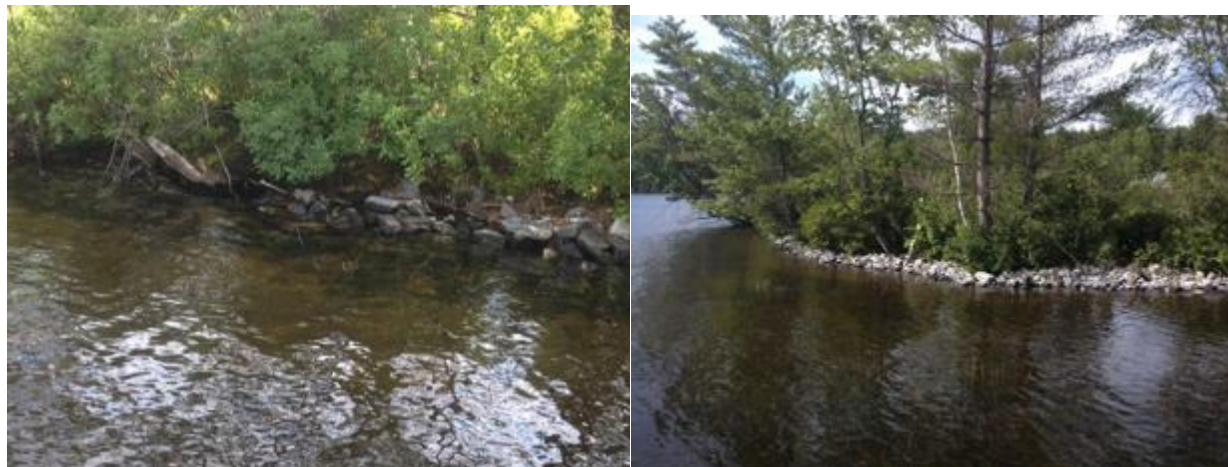
**Otisfield**

Problem: This shore was undercutting as a result of exposure to ice and waves.

Solution: The YCC hand placed rip-rap to armor the shoreline and prevent further erosion.

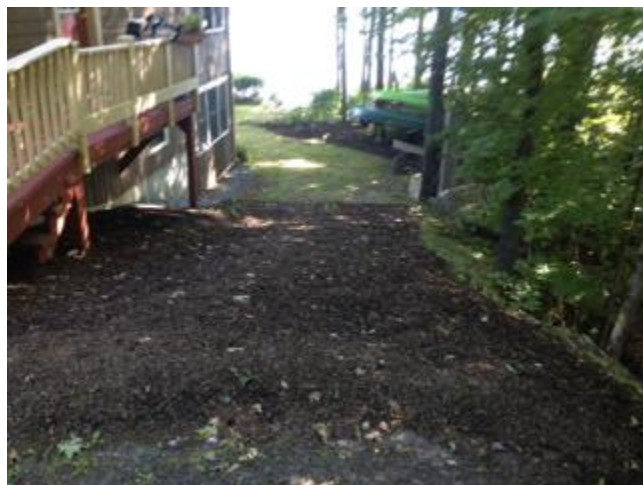
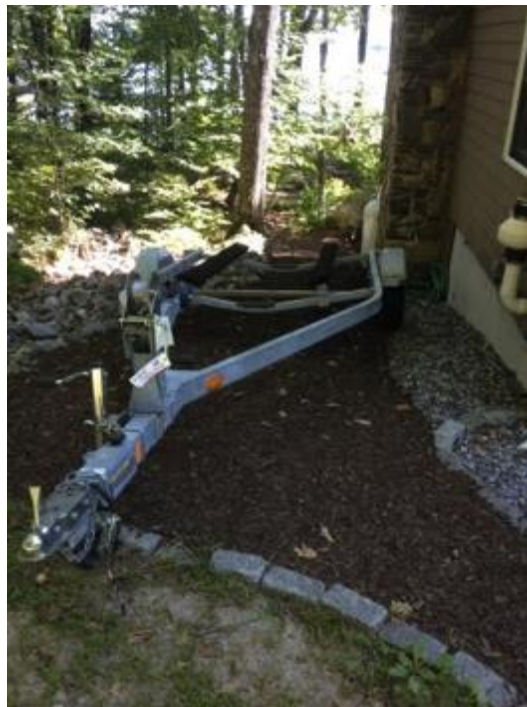
**Casco (319)**

**Problem:** This property had a lot of bare area on his property, leaving it vulnerable to erosion.

**Solution:** The YCC mulched the bare area of his property to reduce the impact of water run-off.

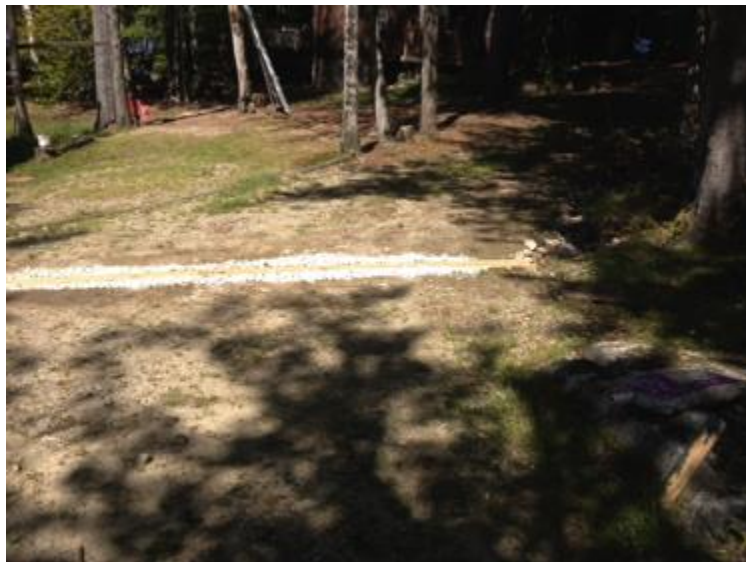
Oxford

Problem: This property has a seasonal run-off channel that runs right through his driveway and underneath his camp.

Solution: The YCC installed a box culvert and two plunge pools to slow down the run-off.

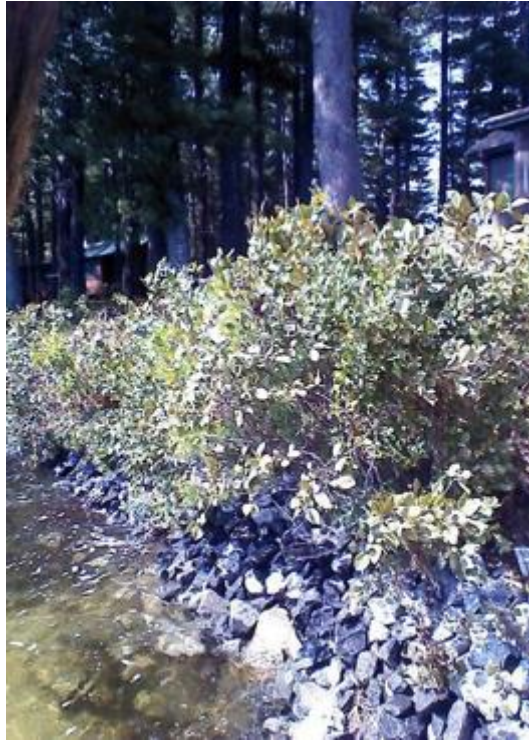
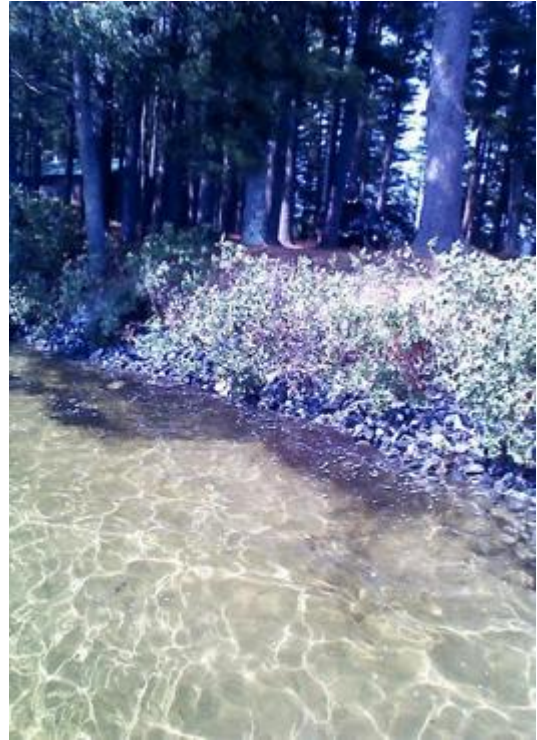
**Oxford**

Problem: This shoreline was eroding due to its exposure to waves and ice.

Solution: The YCC hand-placed rip-rap to protect the shoreline from further erosion.

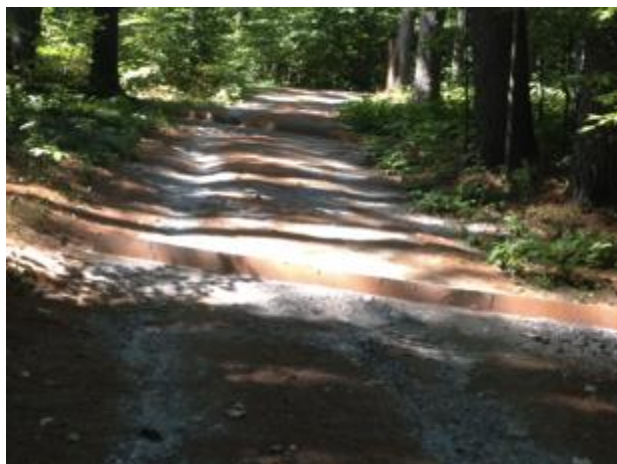
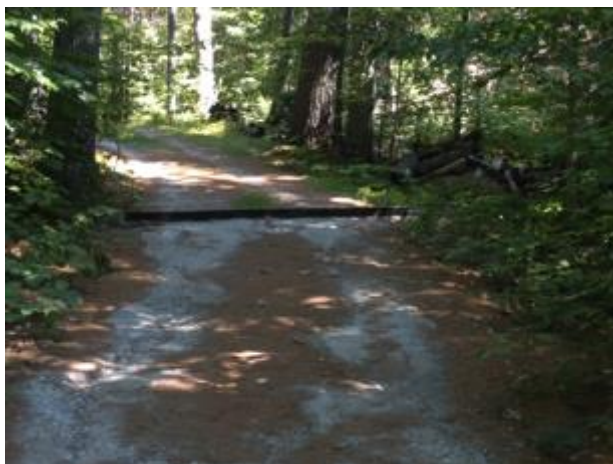
**Otisfield**

**Problem:** This road was experiencing severe scouring that was developing concentrated run-off channels.

**Solution:** The YCC installed 3 Razor bars to divert run-off into the duff layer on the side of the road.

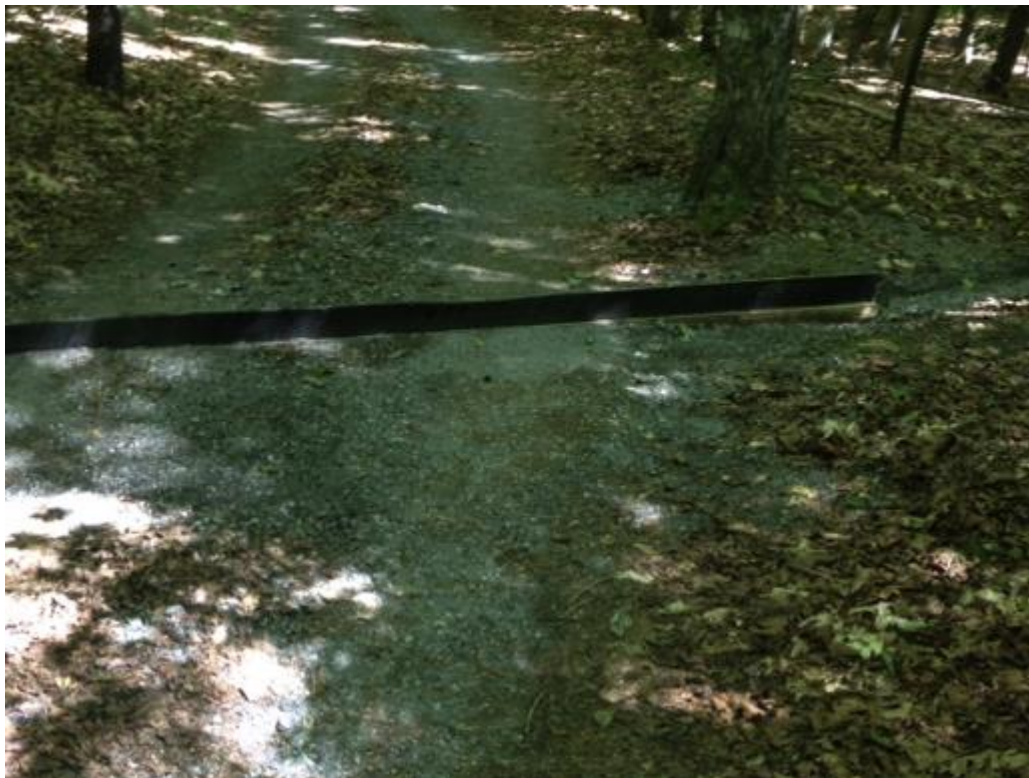
**Otisfield**

Problem: A razor bar in this driveway had ripped.

Solution: After a handful of razor bar failures over the last few years the YCC decided to try a new fabric reinforced rubber. Replace the rubber in this razor.

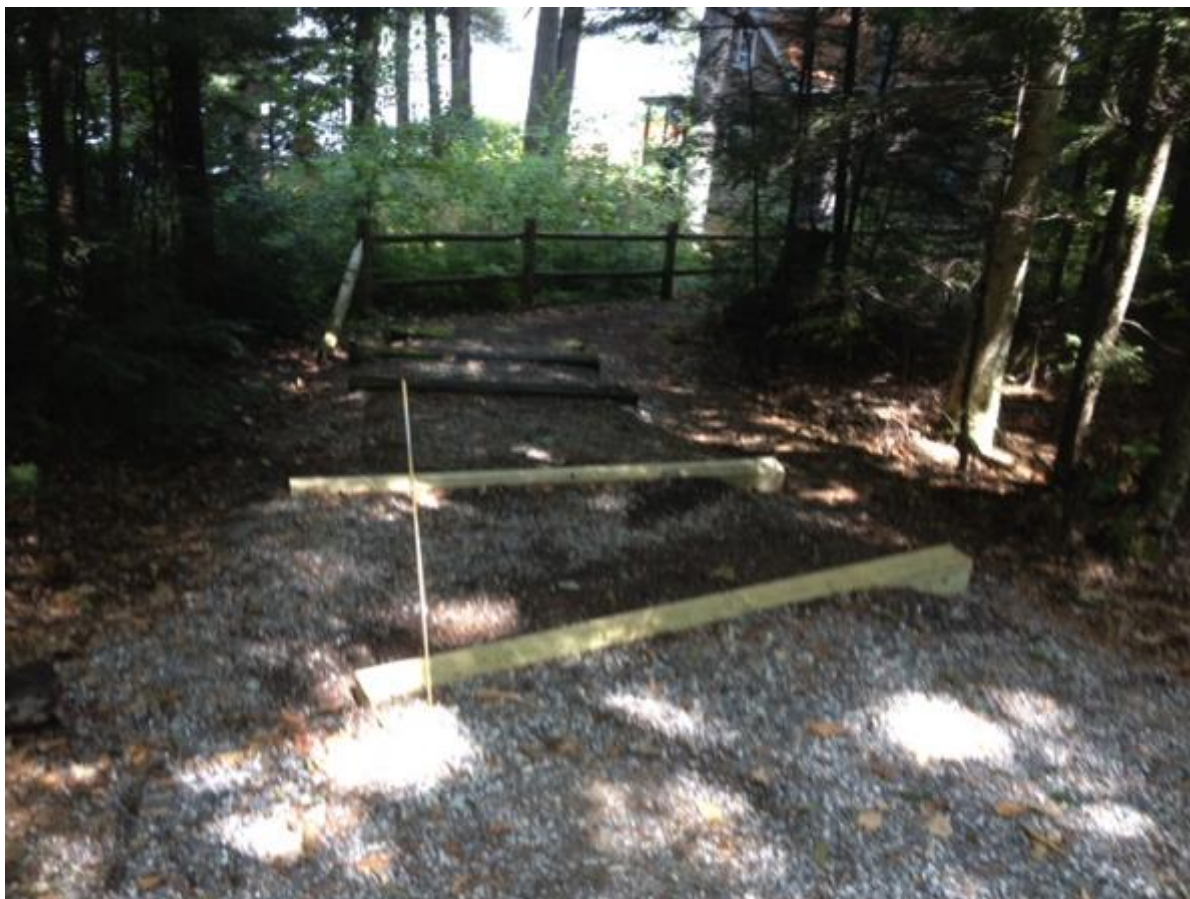
**Otisfield**

**Problem:** The water bars in this pathway from the parking area down to the cottage had rotted out.

**Solution:** The YCC replaced old rotten timbers with new pressure treated timbers. With a recommendation to replace the rest next year and add more stone.

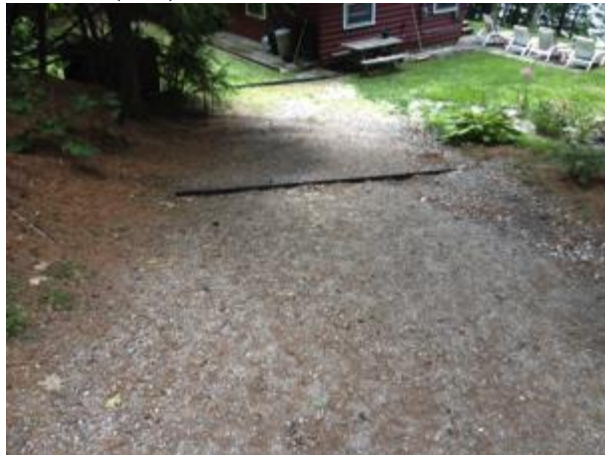
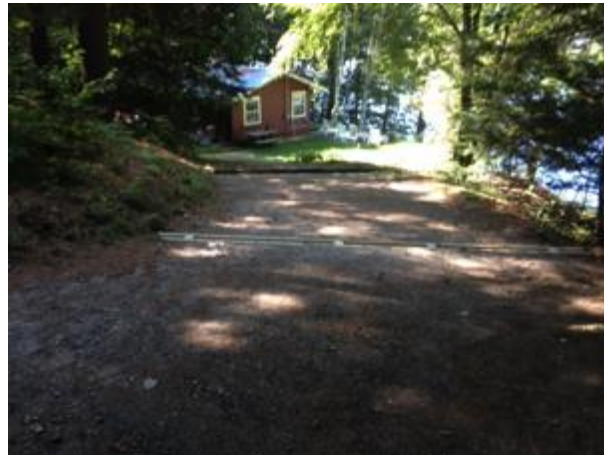
**Poland (319)**

Problem: These water diverters were no longer doing the job. Leading to erosion in the driveway and down the pathway to the lake.

Solution: the YCC took out the defective water diverters and put in a new box culvert and a new razor bar.

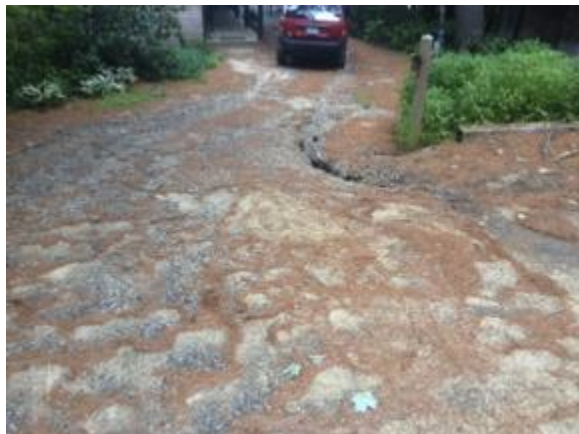
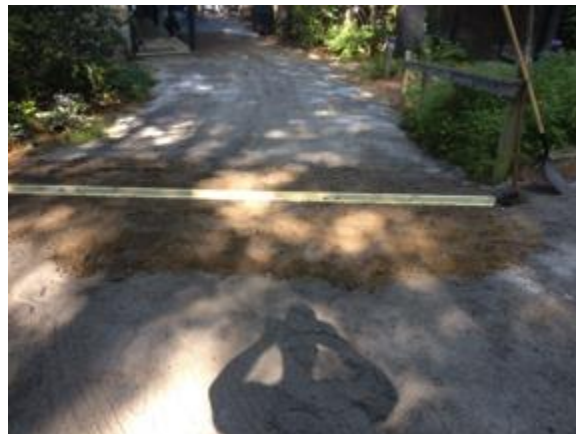
**Oxford**

Problem: This property had severe scouring in the driveway.

Solution: The YCC installed three box culverts, two in Sanborn Lane and one in a private driveway.

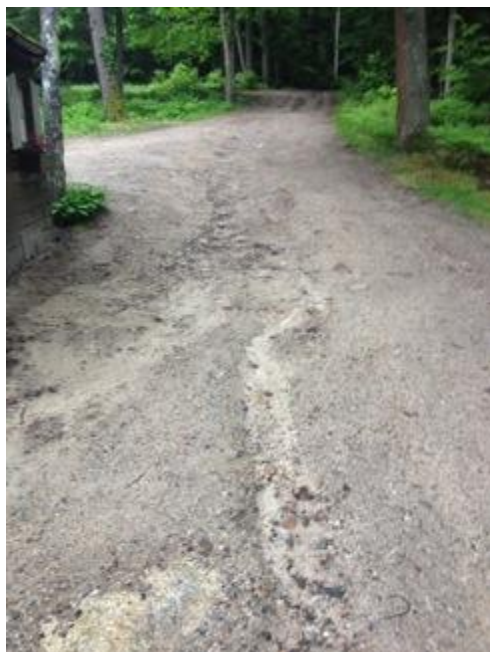
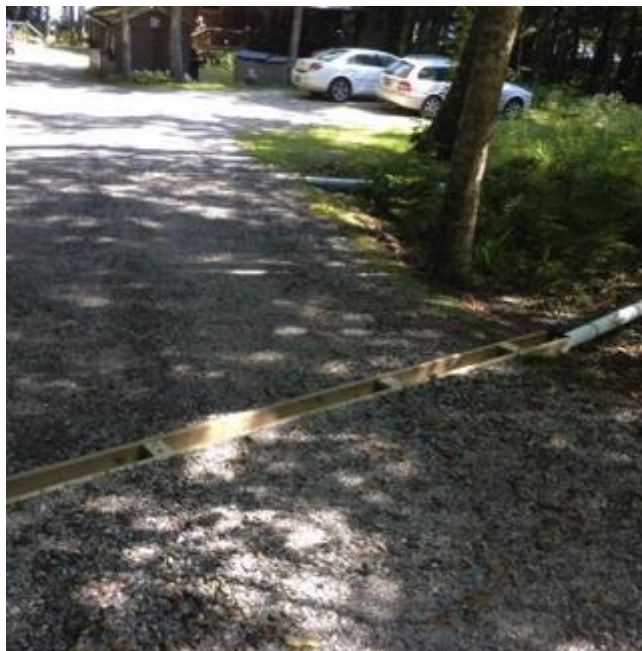
**West Poland (319)**

**Problem:** This property had severe scouring in the driveway and a shoreline that we undercut.  
**Solution:** The YCC resurfaced their driveway with 3/4" crushed gravel and installed three box culverts to divert the water. On the shoreline the YCC hand placed rip-rap where there was undercutting.
