Thompson Lake

Youth Conservation Corps

Final Report 2010

Prepared by: Drew McLaren, Coordinator/Crew Chief

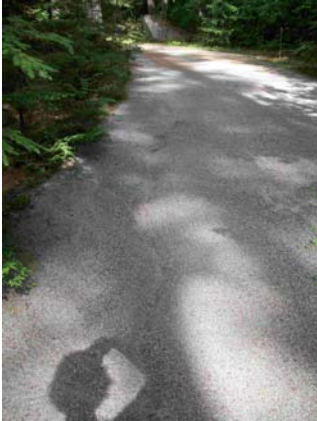
Before:

Problem: Pete Laverdiere’s driveway was scouring, a sign of driveway erosion.

Solution: The Crew installed two box culverts to divert the water off from the driveway.

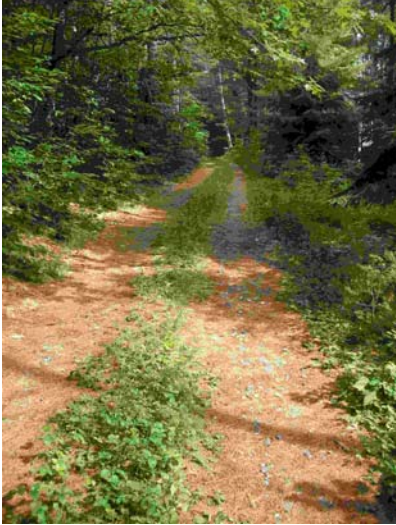
Before:

Problem: Bruce Cummings' driveway was scouring.

Solution: The crew installed two razor bars to divert water off from the drive.

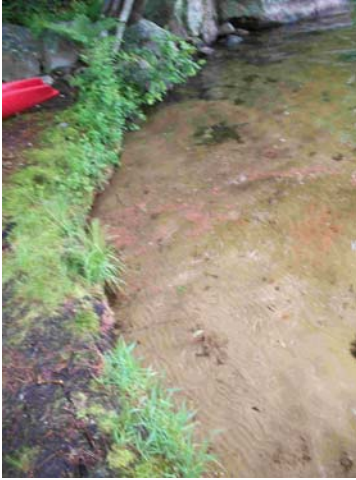
Before:

Problem: The Silvaqua Association beach had a shoreline that was eroding away and had become particularly unstable as well as a pathway that had some erosion.

Solution: The Crew installed a box culvert and more crushed stone on the pathway to prevent further erosion. The crew addressed the shoreline with buffer planting as well as a combination of rip-rap and logs to stabilize the bank.

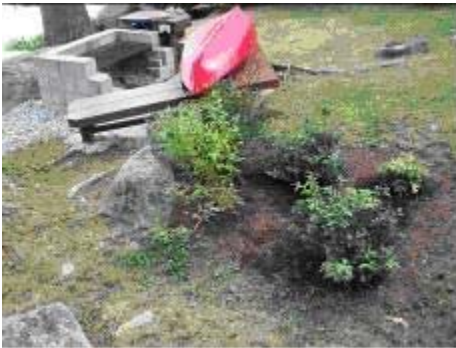
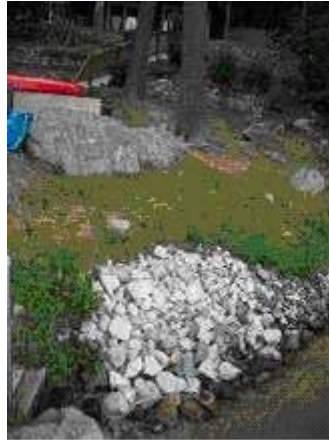
After:

Problem: Dan Porter had direct flow through his lawn to the lake.

Solution: The Crew installed a rain garden to help absorb some of the water flowing through the property and to act as a filter for phosphorus.

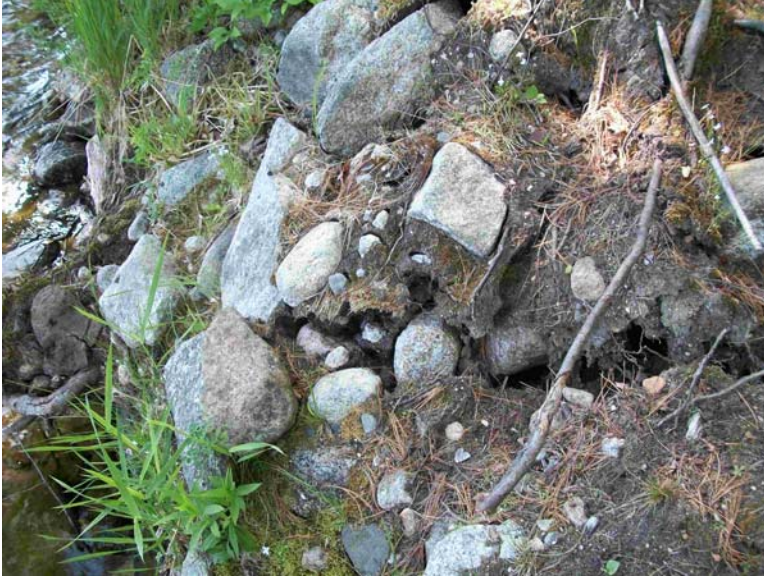
Before:

Problem: Ice pushed the shoreline bank of the Zilinsky/Watson property causing the bank to become severely unstable.

Solution: The Crew installed rip-rap along the whole bank to stabilize the bank and prevent further erosion. The crew also planted more blueberry plants to create a buffer and continue to stabilize the bank.

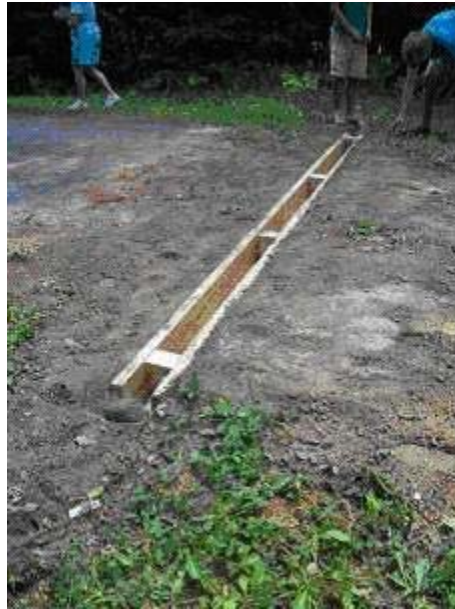
After:

Problem: Ellen Bishop’s razor bar had become no longer functional.

Solution: The Crew replaced the razor bar with a box culvert because the driveway is plowed in the winter.

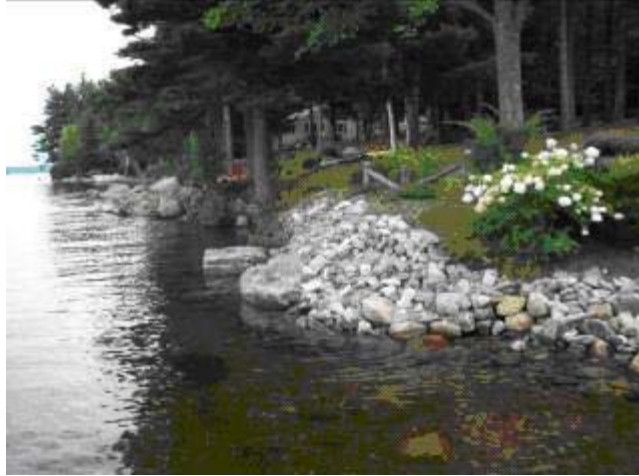
After:

Problem: Lynn O'Brien's shoreline was unstable.

Solution: The Crew continued to rip-rap the shoreline. Part of the shoreline had been rip-rapped in 2009.

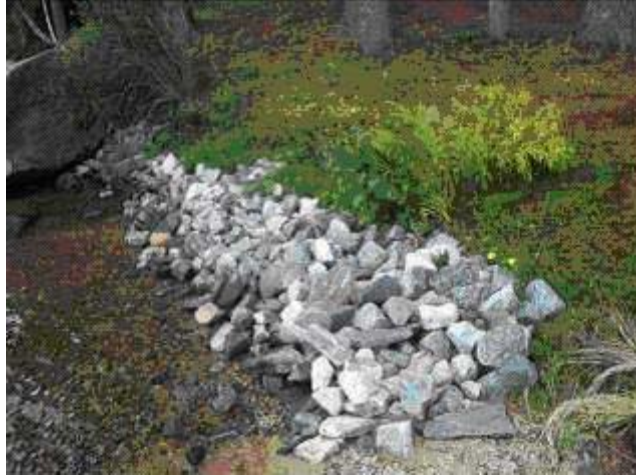
After:

Problem: Dolores Whittum’s shoreline had some minor undercutting.

Solution: The Crew installed rip-rap to stabilize the bank.

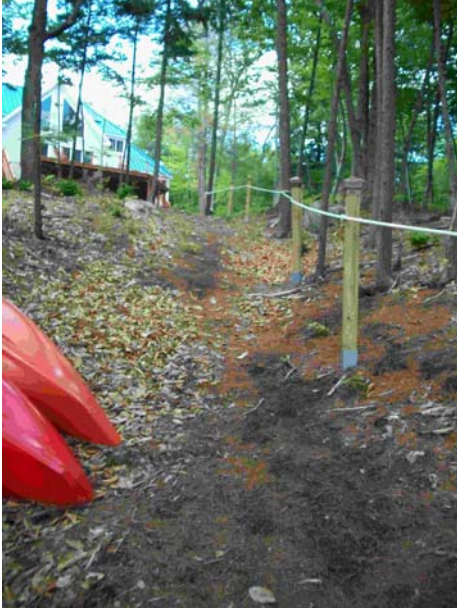
Before:

Problem: Nick Leighton had a pathway with direct flow to the lake.

Solution: The Crew installed two sets of infiltration steps to slow down the flow of water down the path. On either side of the steps the crew spread erosion control mix to stabilize the pathway.

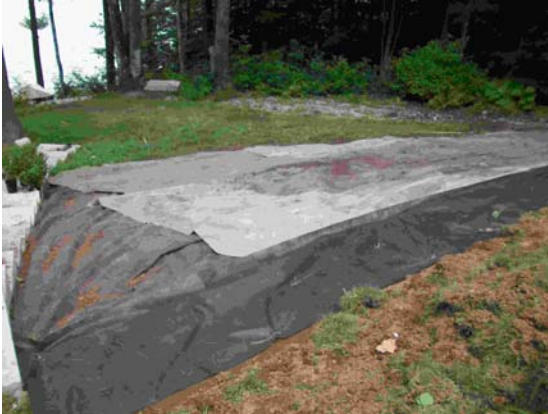
Before:

Problem: Tim Evrard’s boat path to the lake was eroding severely. Tim also had two bare hillsides that were sources for erosion and polluted runoff.

Solution: The crew planted blueberries, juniper rugs, and lilies to vegetate and create a buffer on Tim’s hills.

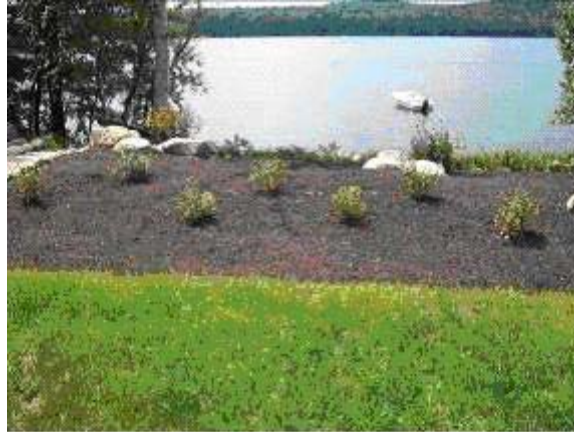
After:

Problem: Kathy Cain was in need of a buffer planting.

Solution: The Crew planted blueberries and lilies to establish this buffer.

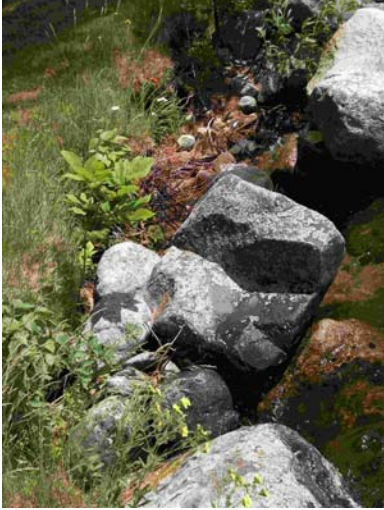
Before:

Problem: Marcia Matuska had no buffer to her shoreline and her bank was undercutting.

Solution: The Crew rip-rapped the bank and planted blueberries above the rip-rap to stabilize the bank.

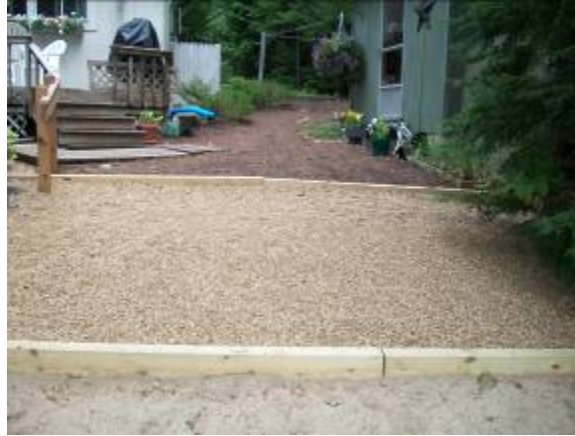
After:

Problem: Lynn Minich had bare areas with direct flow to the lake.

Solution: The Crew replaced old rotted timbers with new pressure treated timbers and established a stone step. The crew also installed a razor bar higher up on the property to divert flow and spread erosion control mulch to absorb the flow.

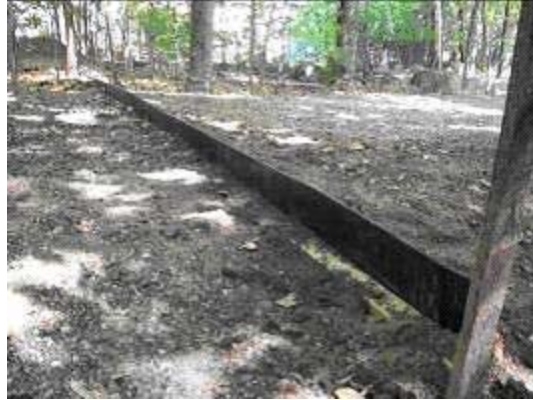
After:

Problem: Moe Ouellette's driveway was scouring.

Solution: The Crew installed a razor bar to divert water and prevent further erosion.

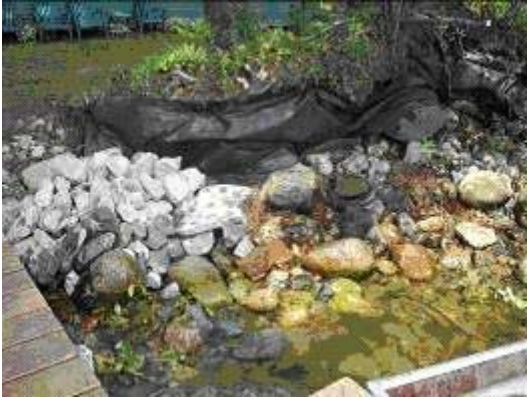
Before:

Problem: Ice had pushed up Ken Craft's shoreline and the waves have continued to eat away the soil.

Solution: The Crew rip-rapped the entire shoreline.

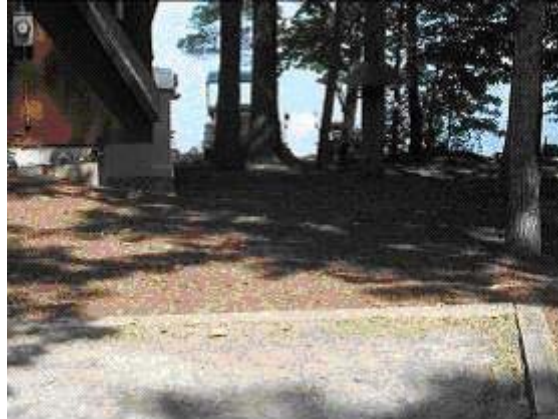
After:

Problem: Will Couture had a lot of bare area on his property.

Solution: The Crew spread erosion control mulch to stabilize the bare area and give the water something to soak into.
